HYUNDAI Technical Service Bulletin	GROUP AUTOMATIC TRANSMISSION	NUMBER 20-AT-018H
	DATE MAY, 2020	MODEL ACCENT (HC) ELANTRA (AD/ADa) ELANTRA GT (PD) KONA (OS) SANTA FE SPORT (AN) TUCSON (TL) VELOSTER (JS)
SUBJECT: AUTOMATIC TRANSMISSION DTC P0880/P088000

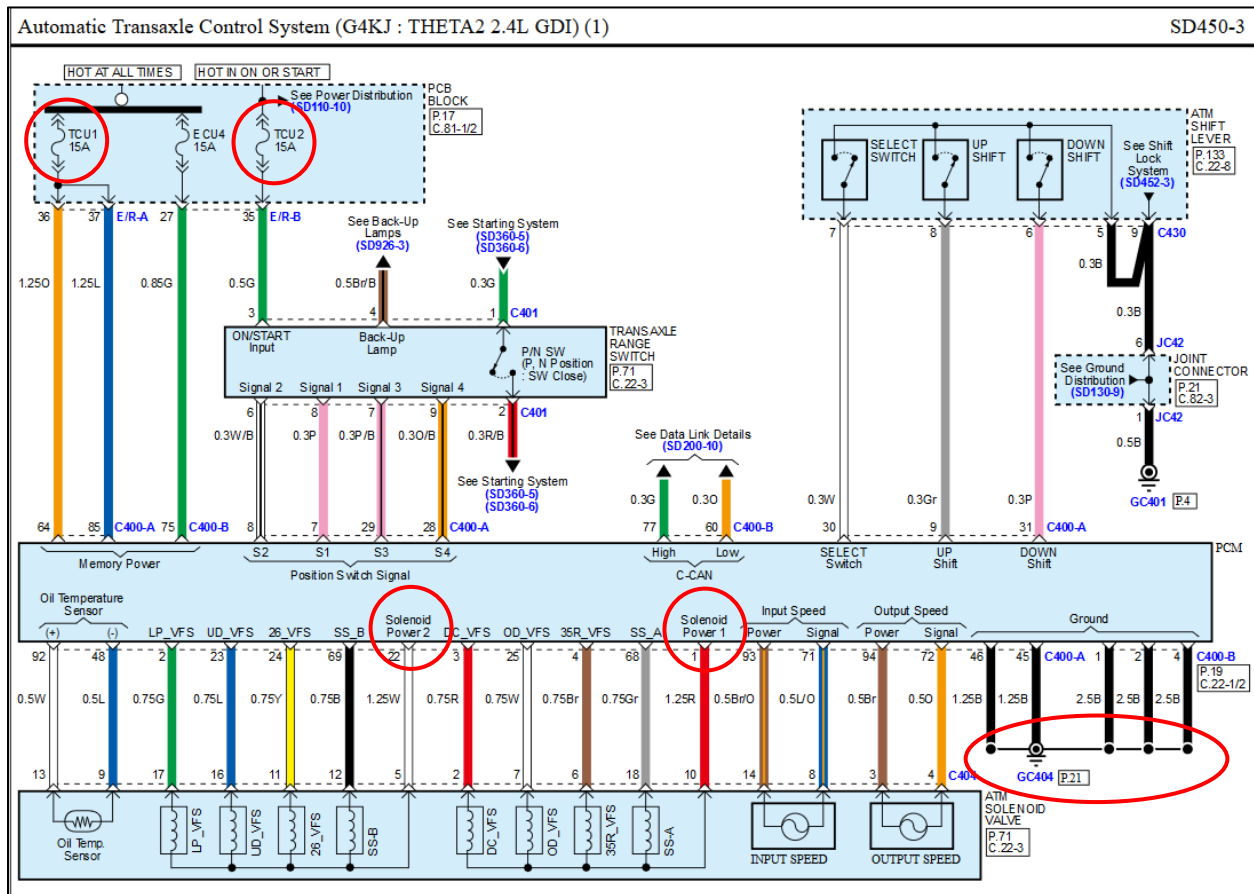
ETM INFORMATION: Example only - refer to the related shop manual:

P0880/P088000 are set when solenoid power voltage is lower than 7v or higher than 22v.

Possible Causes: Poor connection/circuit fault or faulty TCU.

2. Refer to the appropriate shop manual, **Schematic Diagrams, Transaxle/Transmission, Automatic Transaxle Control System** and **Schematic Diagrams**. Check the TCU1 and TCU2 fuses in the E/R junction box (Refer to ETM Information, Page 2). Confirm the fuse fits tightly and does not have an open circuit.

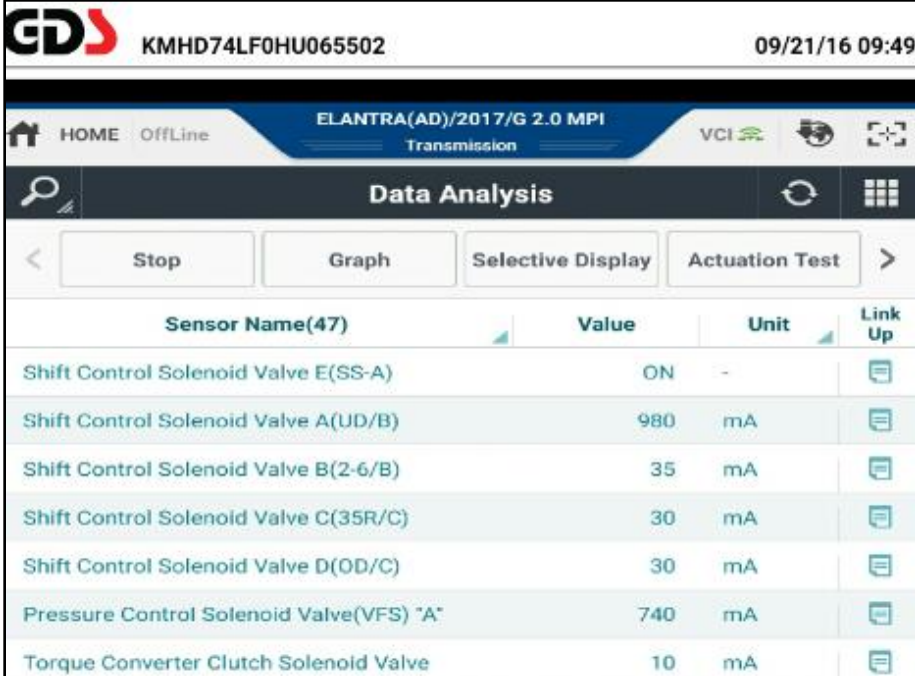
- Continuous and changing output while driving, the solenoids are operating correctly and the wiring **currently** has no open/short circuits. Go to Step 5.

- No continuous and changing output, go to Step 4.
